ALUCOBOND®

QUESTIONS AND ANSWERS

Creative possibilities with the original, aluminium composite panel

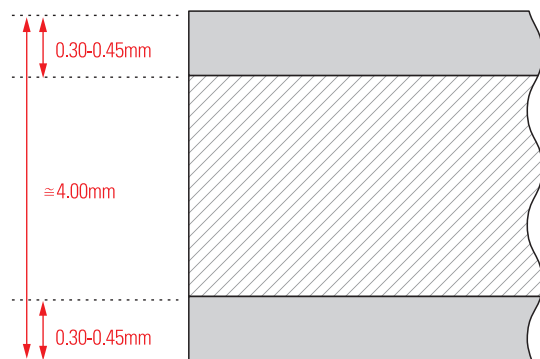
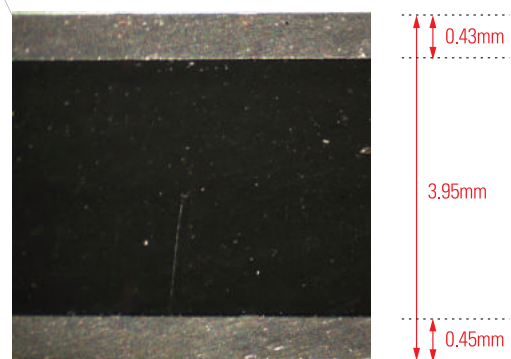
MICROSCOPIC PICTURE

ALUMINIUM SKIN
RECYCLED
POLYETHYLENE CORE
ALUMINIUM SKIN

BRAND: "M"
TESTED BY: MAEK CONSULTANT PTE LTD
DATE: 14 NOVEMBER 2008

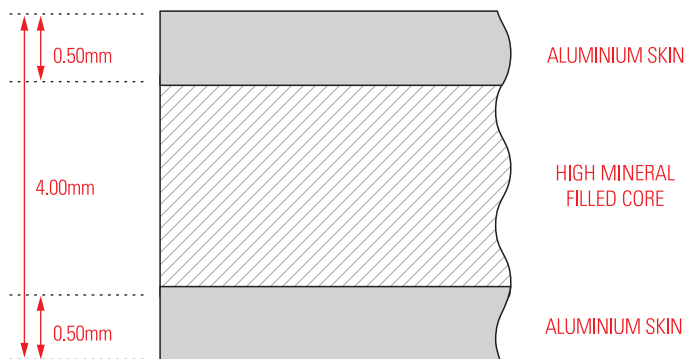
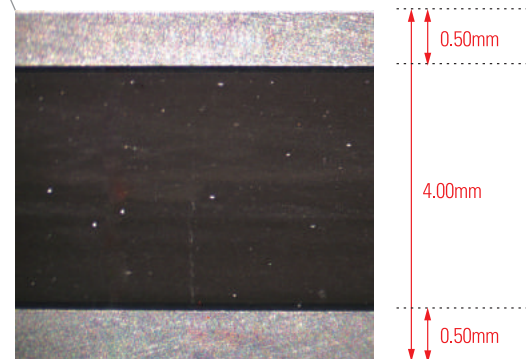
MICROSCOPIC PICTURE

BRAND: ALUCOBOND PLUS
 TESTED BY: MAEK CONSULTANT PTE LTD
 DATE: 14 NOVEMBER 2008

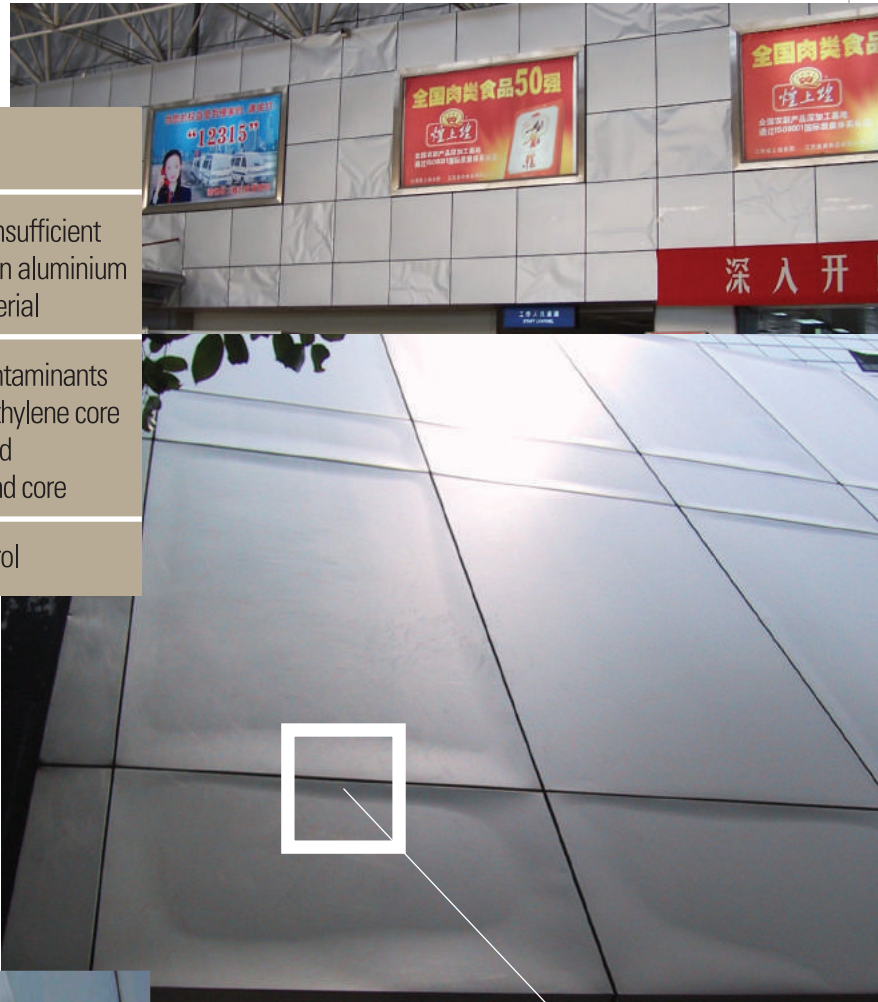
DELAMINATION

- 1 Inferior and / or insufficient adhesive between aluminium skins & core material
- 2 "Bleeding" of contaminants in recycled polyethylene core breaks down bond between skins and core
- 3 Poor quality control

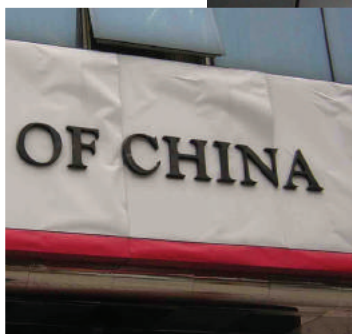
ALUMINIUM SKIN
ADHESIVE
25µm (0.025mm)
RECYCLED
POLYETHYLENE CORE

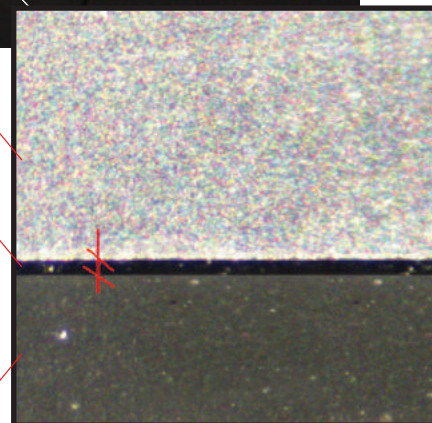
MICROSCOPIC PICTURE

BRAND: A1
TESTED BY: MAEK CONSULTANT PTE LTD
DATE: 14 NOVEMBER 2008

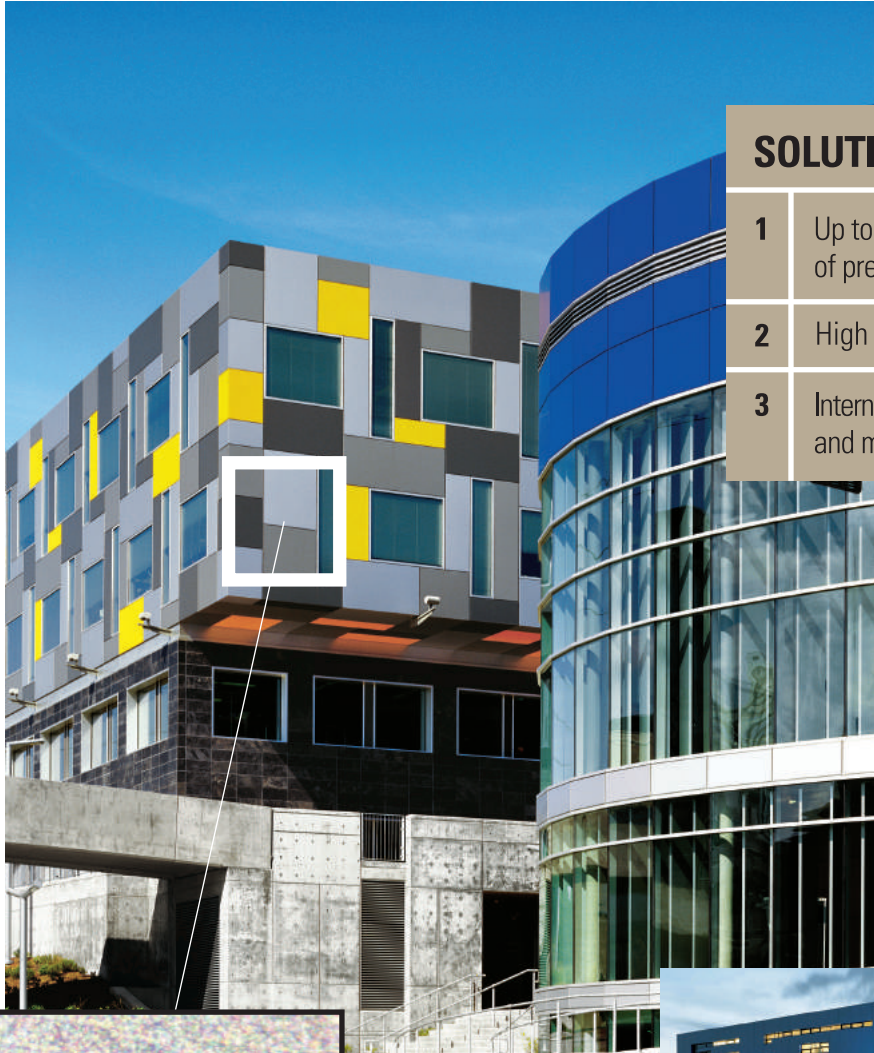
- 1 Up to 3 times thicker layer of premium adhesive
- 2 High mineral filled core
- 3 International quality standards and manufacturing control

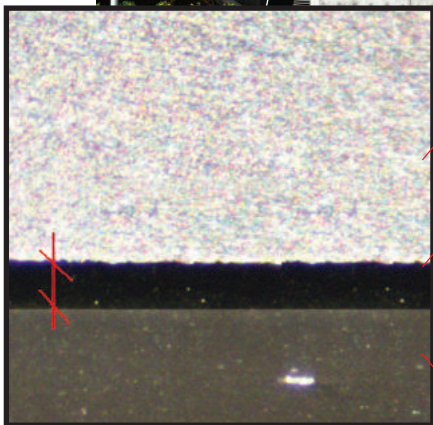
MICROSCOPIC PICTURE

ALUMINIUM SKIN

ADHESIVE

75µm (0.075mm)

HIGH MINERAL FILLED CORE

BRAND: ALUCOBOND PLUS
TESTED BY: MAEK CONSULTANT PTE LTD
DATE: 14 NOVEMBER 2008

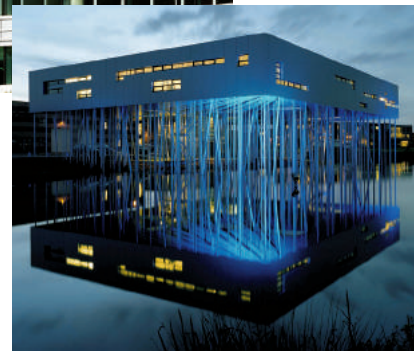
ALUMINIUM CENTRUM HOUTEN, NETHERLANDS

The headquarters of the Dutch aluminium industry, the Aluminium Centrum, is fully clad with ALUCOBOND® composite materials.

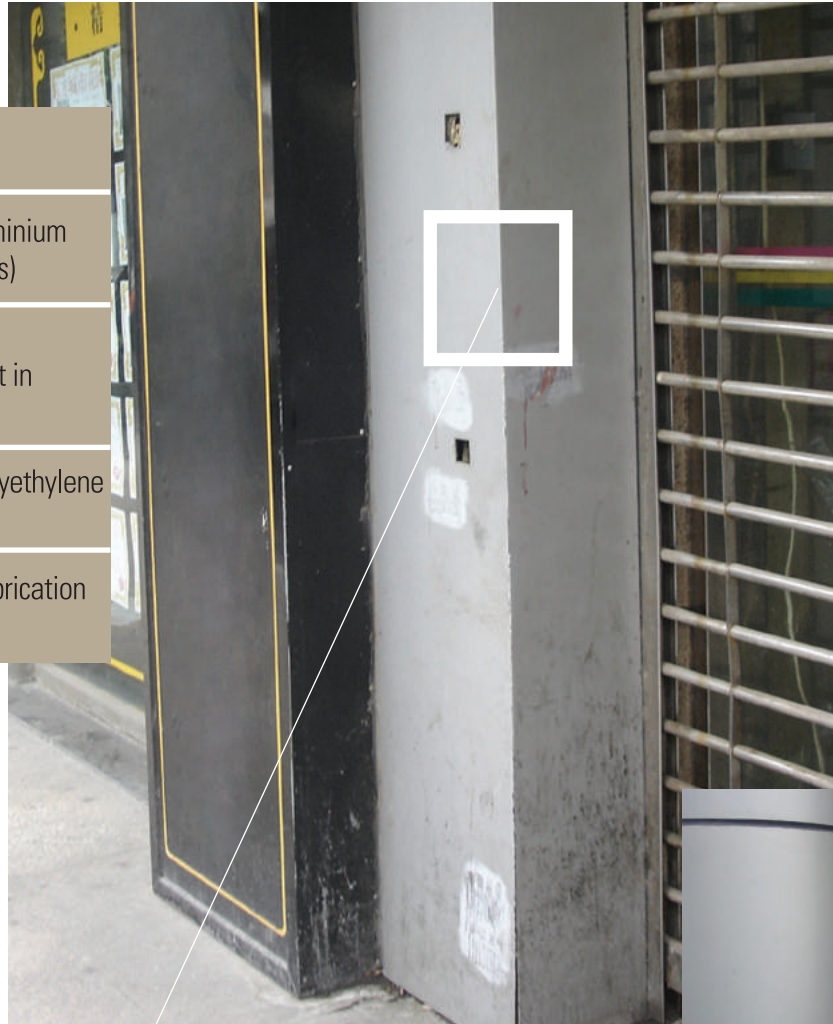
CRACKS AND DENTS

- 1 Use of inferior aluminium alloy (eg 1xxx series)
- 2 Inconsistent panel thickness can result in weaker panels
- 3 Use of recycled polyethylene core materials
- 4 Use of incorrect fabrication equipment

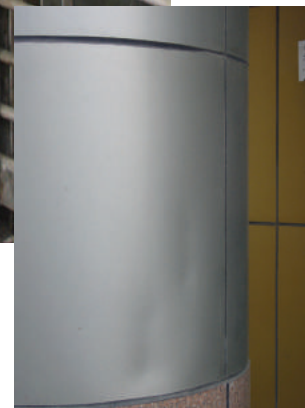
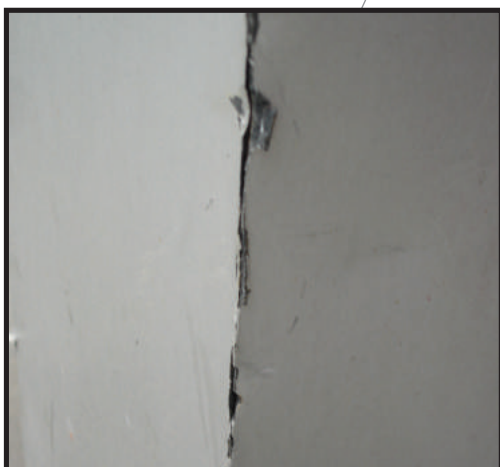
ALUMINIUM ALLOY

1xxx series aluminium alloy is an inferior metal commonly used in cooking pots and pans. Its lack of tensile strength may result in pressure cracks and dents when used in composite panels.

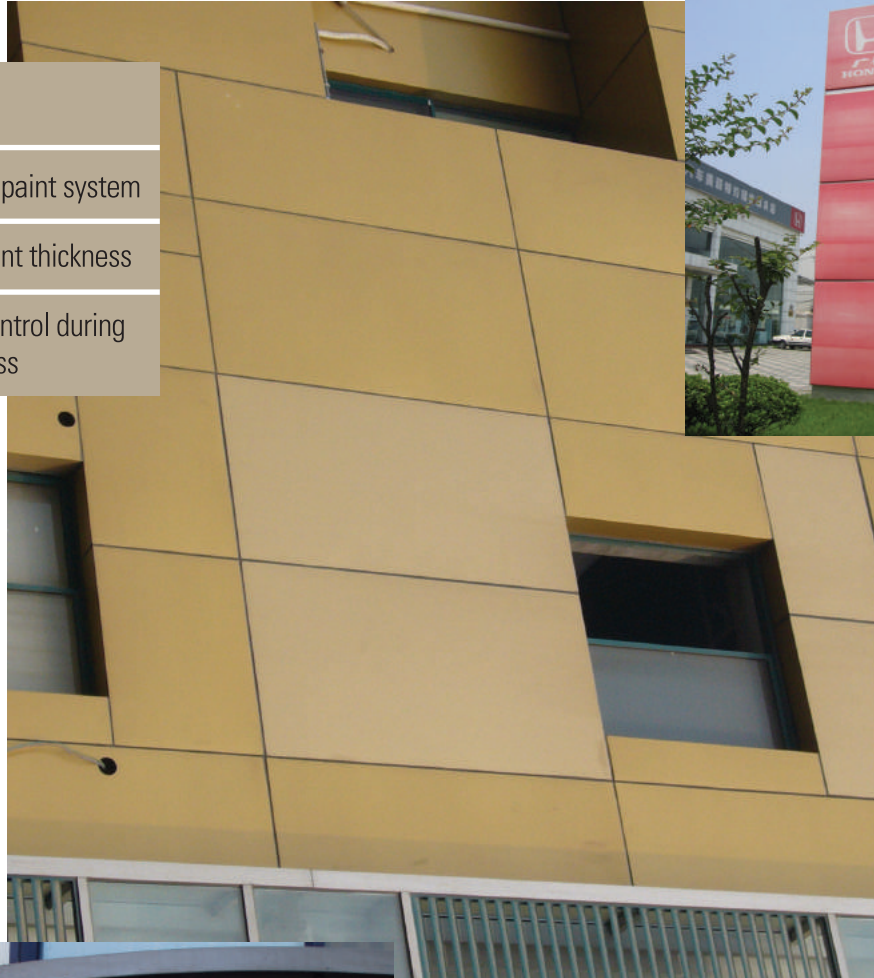
COLOUR FADING, PEELING & INCONSISTENCIES

- 1 Use of inferior paint system
- 2 Insufficient paint thickness
- 3 Poor quality control during painting process

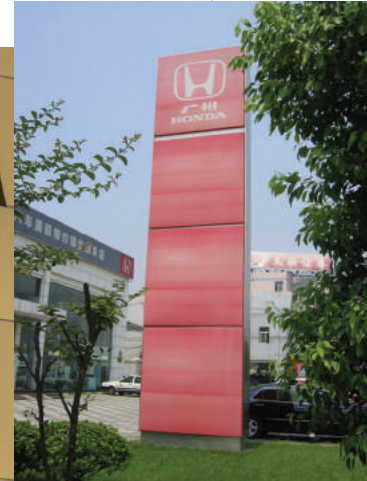
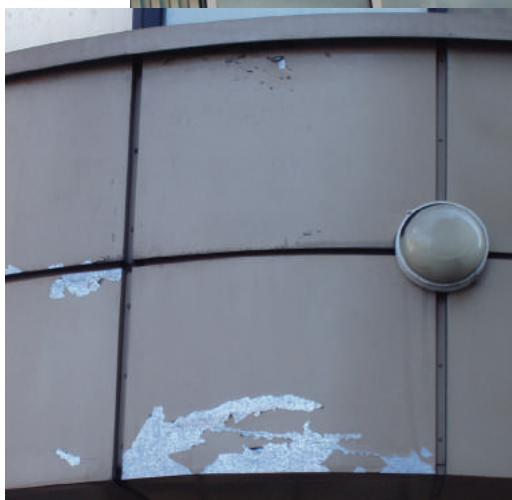
WEATHERING TEST RESULT

PAINT QUALITY OF INFERIOR ALUMINIUM COMPOSITE PANEL

FLORIDA EXPOSURE 45 SOUTH. EXPOSED SINCE 1987

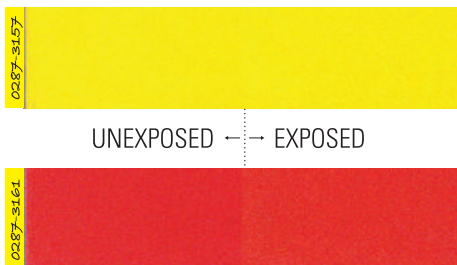
WEATHERING TEST RESULT

ALUCOBOND QUALITY

FLORIDA EXPOSURE 45 SOUTH. EXPOSED SINCE 1987

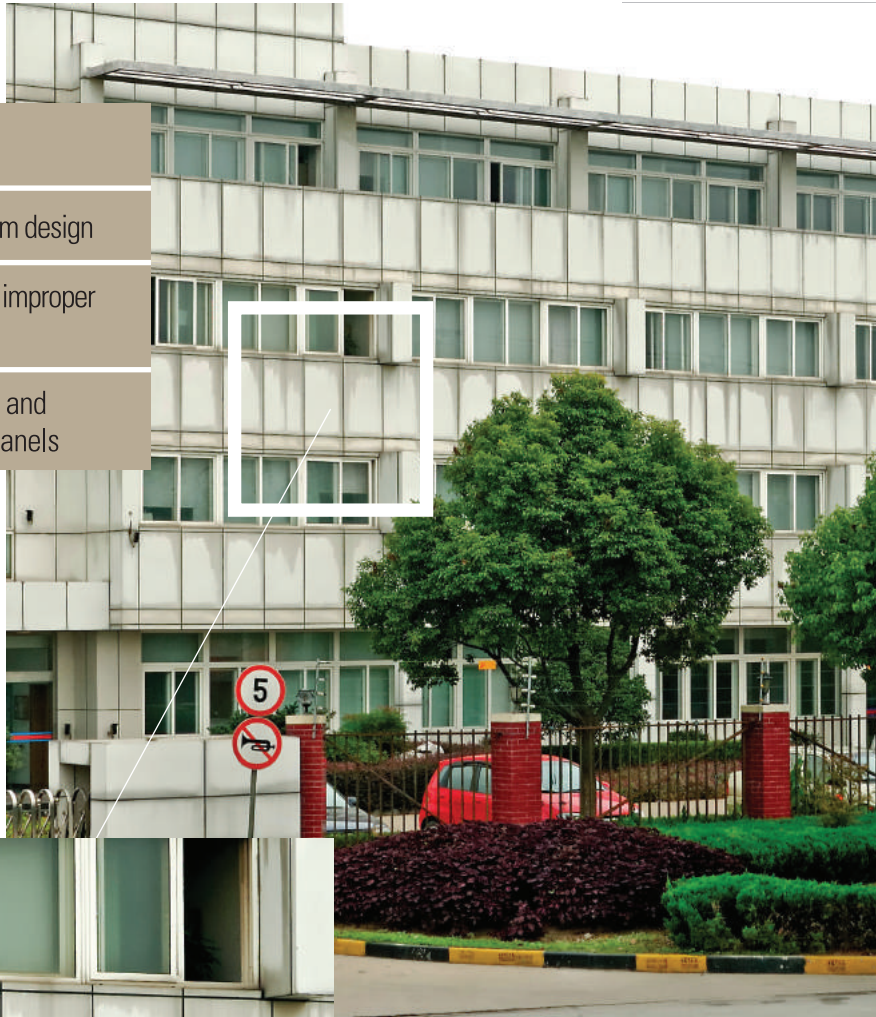
STREAKING & STAINING

- 1 Poor fixing system design
- 2 Poor quality and improper use of sealant
- 3 Poor fabrication and installation of panels

BUILDING CLEANED REGULARLY
BUT STAINING CANNOT BE REMOVED

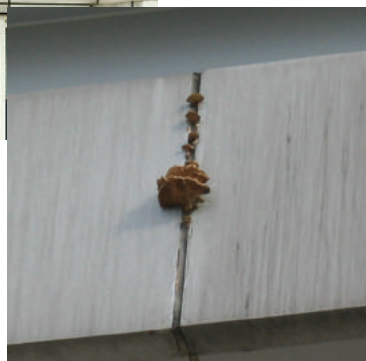
STREAKING & STAINING

Poor application and quality of façade products can lead to unsightly stains and fungal growth.

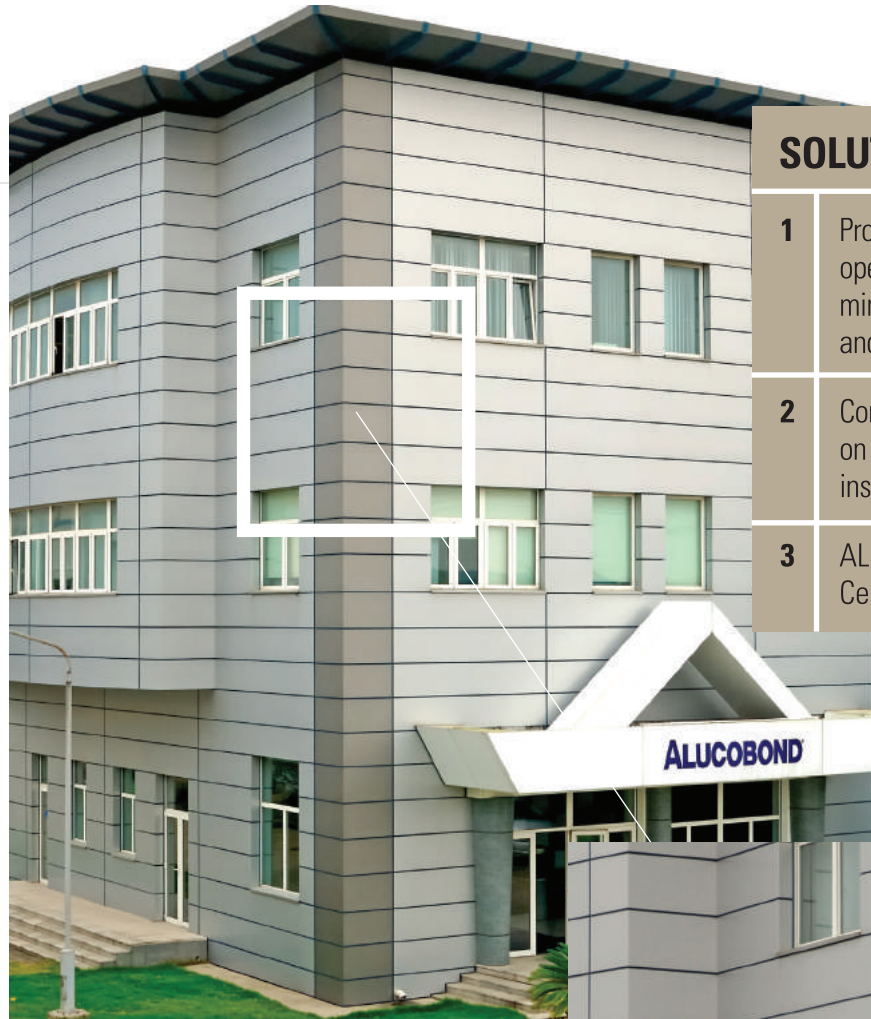
- 1 Proven and patented* open joint system design minimizes streaking and staining
- 2 Complementary consultancy on proper fabrication and installation techniques
- 3 ALUCOBOND® Fabricator Certification Programme

TEN YEAR OLD FAÇADE OF ALUCOBOND® OFFICES WITH A PROVEN SYSTEM

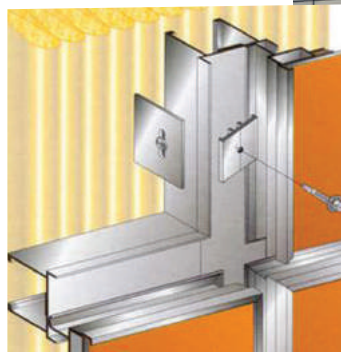
PROVEN AND PATENTED* OPEN JOINT FIXING SYSTEM

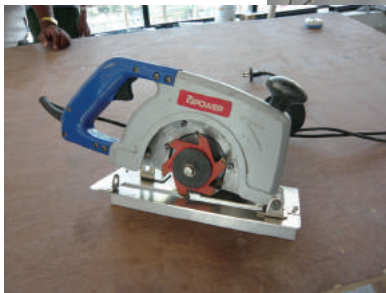
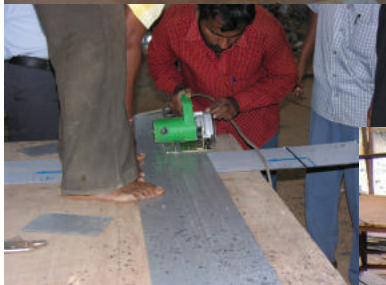
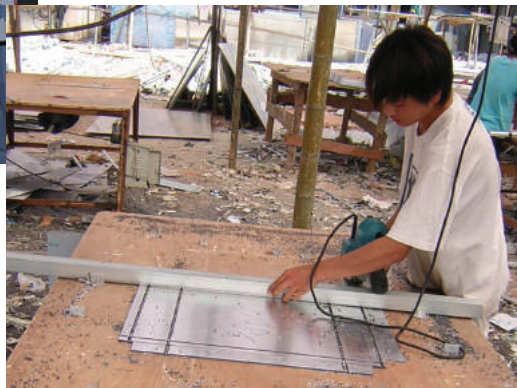
MANUAL FABRICATION OF PANELS USING LOW SKILLED LABOUR, INFERIOR EQUIPMENT AND TECHNIQUES.

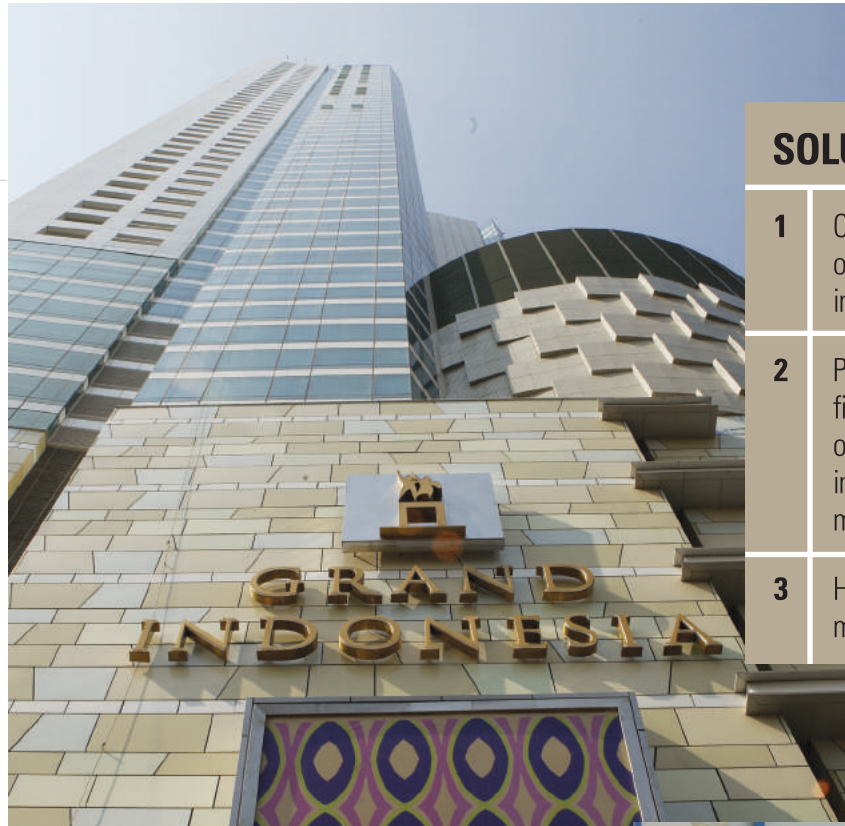
- 1 Complementary consultancy on proper fabrication and installation techniques
- 2 Proven and patented* fixing system design. Supply of pre-routed panels using in-house state of the art manufacturing equipment
- 3 High quality cladding materials proven since 1969

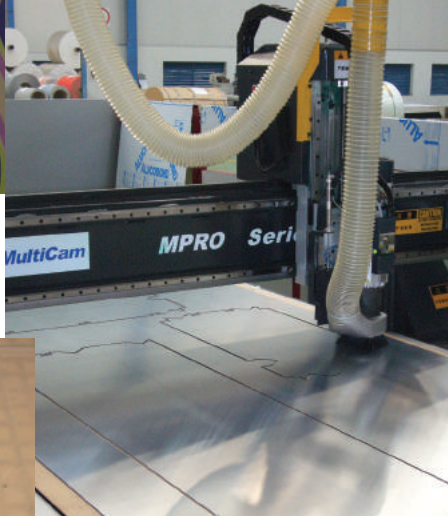
SUPPLY OF IN-HOUSE PRE-ROUTED PANELS
